TECHNICAL NOTE 3973

ORIGIN AND PREVENTION OF CRASH FIRES IN TURBOJET AIRCRAFT

By I. Irving Pinkel, Solomon Weiss, G. Merritt Preston,
and Gerard J. Pesman

Lewis Flight Propulsion Laboratory
Cleveland, Ohio

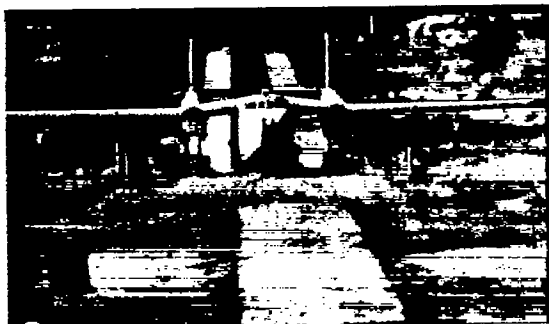
The appearance of the airplane as it struck the barrier is shown in figure 2(a). The cloud of fuel mist (liquid droplets suspended in air) that appeared when fuel spillage occurred while the airplane was in motion is evident at the breach in both wings (fig. 2(b)). Red dye in the fuel accounts for the bright color of the fuel cloud. As the crashed airplane slowed, the fuel mist moved forward of the wing and reached the air inlet on the left engine (fig. 2(c)). A strong cross wind swept the fuel mist away from the engine on the right wing.

(a) Airplane contacting barrier.

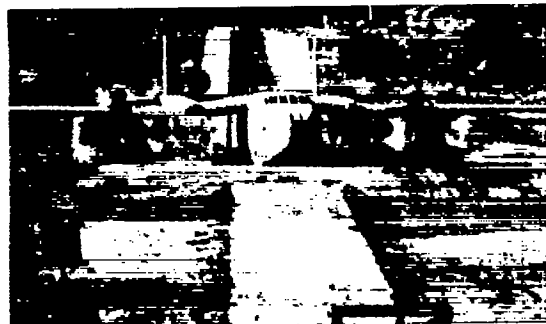
(b) Fuel-mist cloud, 0.8 second after initial impact.

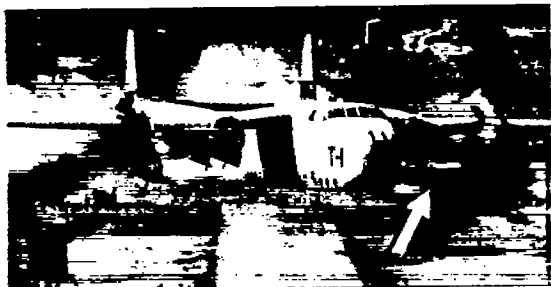
(c) Fuel mist entering left engine, 2.5 seconds after initial impact.

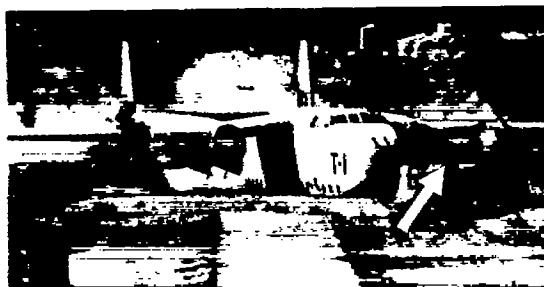
Fuel mist ingested by the left engine was ignited somewhere within the engine. The ignited fuel mist produced the flames at the tailpipe and inlet shown in figure 2(d). These exposed engine flames ignited the fuel spilling from the wing (fig. 2(e)). The flame spread through this fuel to the wing to produce the stable fire shown in figure 2(f).

Flames originating within the engine may also appear at the engine inlet as observed in figure 2(d). The appearance of this inlet flame may be explained in the following way. Burning of ingested fuel in the combustor flame reduces the turbine-inlet gas density. A higher pressure in the combustor is required to pass the gas through the turbine. When an abrupt change in over-all combustor fuel-air ratio is provided by the ingested fuel, the pressure in the combustor required to pass the combustor gas through the turbine may exceed the capability of the compressor at the existing rotor speed. The compressor flow may stall before the turbine can accelerate the rotor to a speed that will provide the necessary pressure. At this moment the combustor flame may propagate upstream through the ingested combustible mixture that fills the stalled compressor and exit at the engine inlet.

(d) Fire at engine inlet and tailpipe of left engine, 2.6 seconds after initial impact.

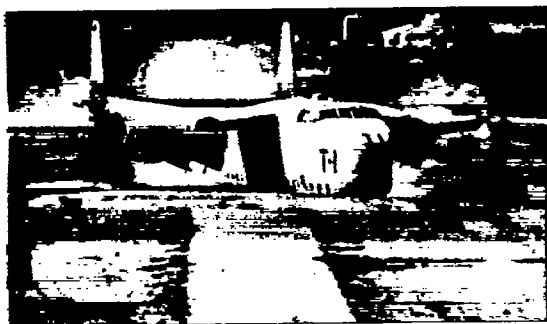
(e) Fire spread to fuel mist issuing from left wing, 2.8 seconds after initial impact.

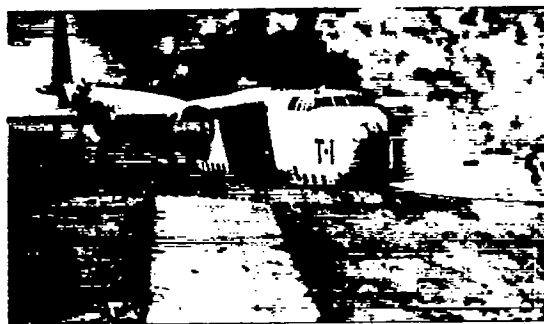
(f) Spread of fire, 4.0 seconds after initial impact.

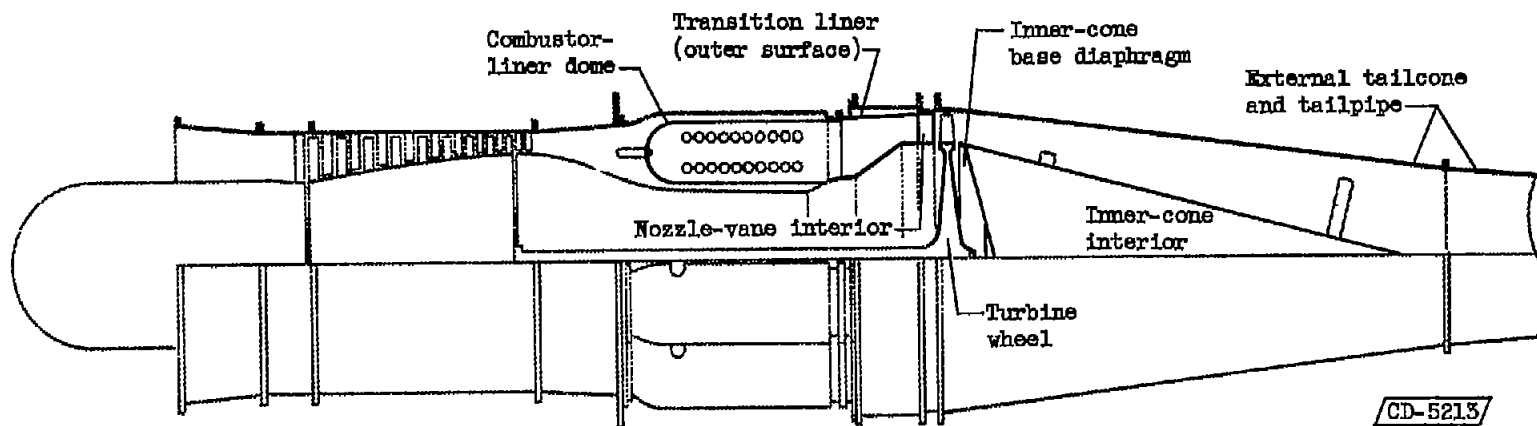
The ignition zones were identified in test-stand engines by the method discussed in detail in appendix C. The technique employed involved the use of fuel sprays local to the engine zone suspected as an ignition source. Following engine operation at rated conditions for a time sufficient to establish temperature equilibrium, the fuel flow to the combustor was turned off and the fuel spray was turned on local to the zone under study. The fuel flow was programmed to maintain a combustible atmosphere in the zone. If ignition occurred, inerting means were installed to prevent the ignition in subsequent tests of upstream zones. By starting at the downstream end of the engine and proceeding upstream in this way, each ignition zone was identified and inerted in turn. As a final check after all the zones were inerted, fuel was injected into the main gas stream to determine whether ignition would occur. In this manner, ignition zones were found on the combustor liner, transition liner, turbine and inner-cone base diaphragm, and tailcone and tailpipe (fig. 11).

Figure 11. - Hot-metal ignition zones found in J35 engine.

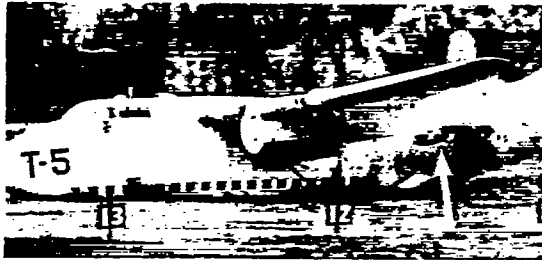
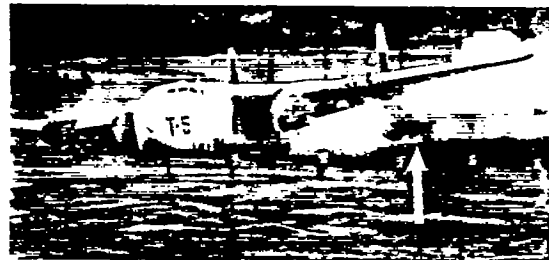
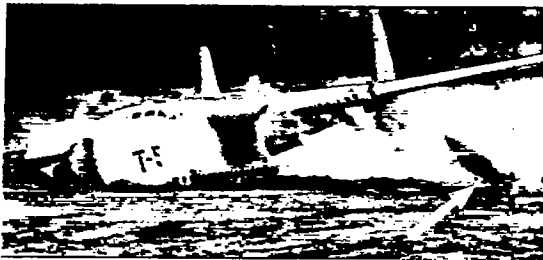
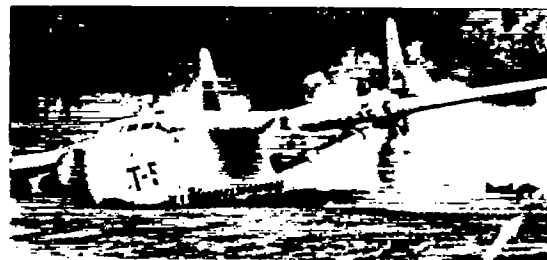
Figure 24. - Separation of J47 engine from C-82 wing in crash.

Separation of the engine from the wing is shown in the picture sequence of the crash in figure 24. After separation (fig. 24(a)) the engine tumbled in the fuel spraying into the wake of the damaged wing (figs. 24(b) and (c)) and came to rest in the fuel-wetted slide path of the airplane (fig. 24(d)). The plume of condensed water vapor at the tailpipe (fig. 24(a)) shows that the water inerting system was actuated. No fire occurred.

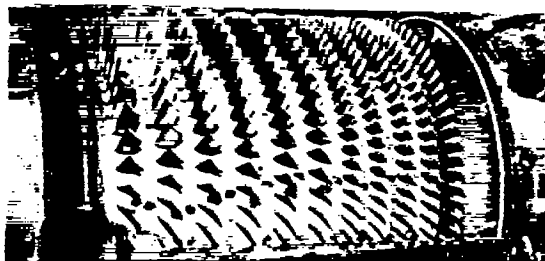
Figure 26. - Fuel-dye stains on J35-engine compressor following F-84 crash.
